## Case Report

# Silastic Electrode Positioner Extrusion as a Late Complication of Cochlear Implantation Surgery

**KEYWORDS:** Cochlear implant, electrode extrusion, electrode positioner

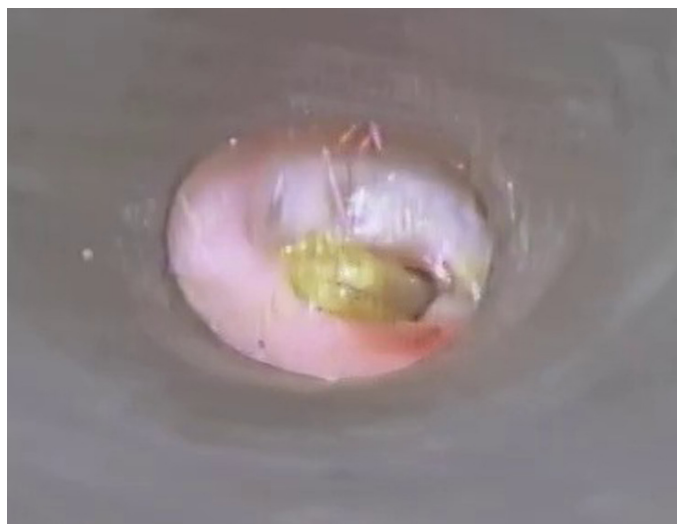
**Figure 1.** Electrode positioner extrusion through the tympanic membrane.

In December 2019, she came to our center complaining of ear pain and some episodes of otorrhea in her right ear. During examination upon removing cerumen from the canal, we noticed a solid object extruded from the posterior part of the tympanic membrane. After a thorough microscopic examination, we found that it could be the Silastic electrode positioner. The results of functional tests were normal (Figure 1).

For the safety of the patient, we did not manipulate the positioner in the clinic. The patient underwent surgery under general anesthesia. The ear canal was cleansed. About 2 mm of Silastic positioner was extruded from a posterior perforation in tympanic membrane. Other parts of the membrane were normal without any evidence of retraction, effusion, and sclerosis. An incision was made in the canal skin about 8 mm away from the annulus ring. Tympanomeatal flap was elevated and after tympanotomy, the middle ear was opened. To make sure to avoid traumatizing the tympanic membrane, tympanomeatal flap was split. The middle ear showed no evidence of infection. The main electrode was in its right position in the cochleostomy site but the positioner was displaced from the cochleostomy site through the tympanic membrane (Figure 2).

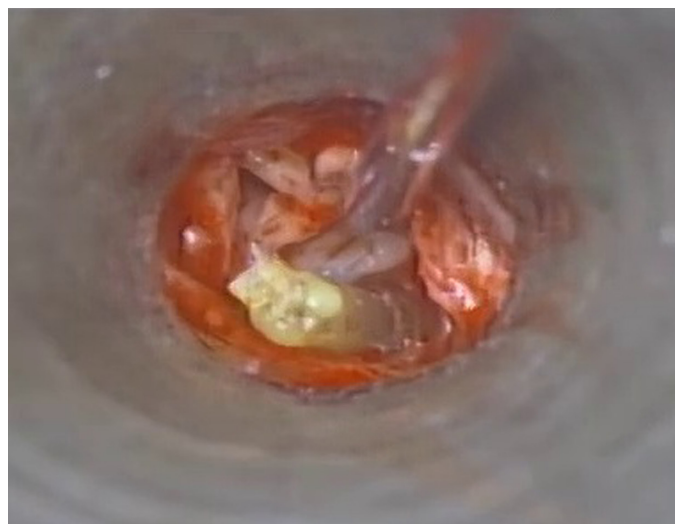
**Figure 2.** Electrode positioner extruded from the cochleostomy site.

With the cradle of the main electrode, the positioner was removed and the cochleostomy opening was sealed with perichondrium. Then cartilage tympanoplasty with temporalis muscle fascia was performed for repairing the perforated tympanic membrane. Intravenous antibiotics were used only during the perioperative

In our case, to prevent movement or extrusion of the main electrode, we did not remove the positioner through the tympanic membrane. Instead, we took the patient to the operating room, and under the direct inspection of the cochleostomy site and catching on the main electrode to ensure it is not moving out, the positioner was removed gently and cochleostomy site was sealed immediately to minimize the risk of infection.

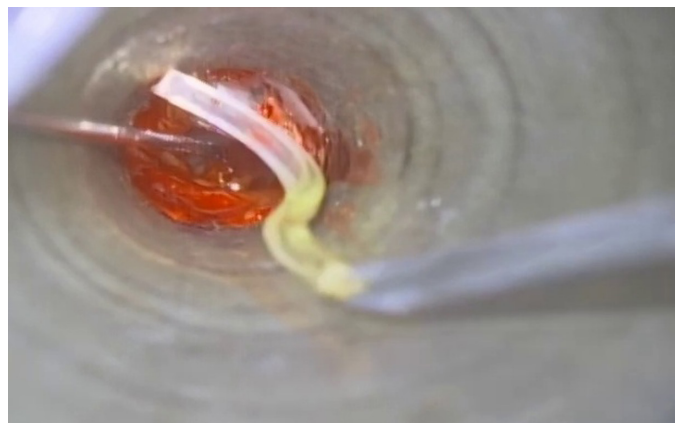
**Figure 3.** Removing the electrode positioner.

period. Antibiotics were prescribed for the duration of 1 week post-surgery (Figure 3).
